# BUILDING INSPECTION REPORT

14 Elm Grove, Corstorphine, Edinburgh EH12 7AB

**Date of Survey: 08/09/2026**

# 14 Elm Grove, Corstorphine, Edinburgh, EH12 7AB

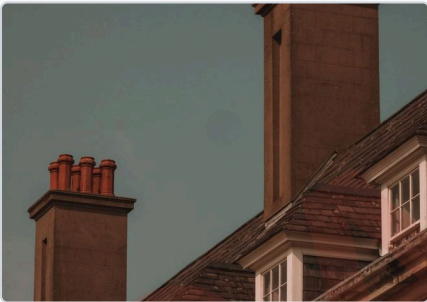
| <div>Cat 3</div> <p>Urgent repairs or replacements are needed now. Failure to deal with them may cause problems in other parts of the property or cause a safety hazard.</p> | Condition | Two chimney stacks on the front elevation in facing brick with a cement render finish. The render has cracked and come away in places, leaving the brickwork exposed to the weather, and there is open jointing to the upper courses. The lead flashings at the base of the rear stack have lifted and no longer form a proper seal. Vegetation is growing from the mortar joints, which points to moisture sitting in the brickwork for some time. |

1a Front stacks: cracked render and open joints to the upper courses

| | Action | Hack off the failed render and re-render with a keyed sand and cement mix with a bellcast at the base. Rake out and repoint the open joints, re-bed the pots and flaunching, and renew the lead flashings with Code 4 lead dressed into the slates. Remove the vegetation and treat the joints before repointing. |

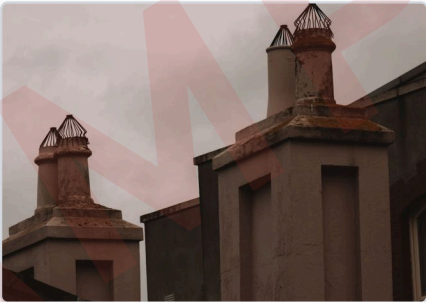
1b Rear stack: vegetation in the joints and lifted flashing at the base

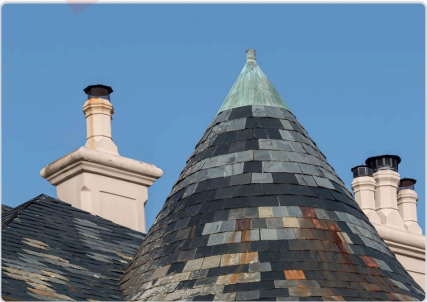
1c Rear stack from the ridge: flashing no longer sealed to the slates

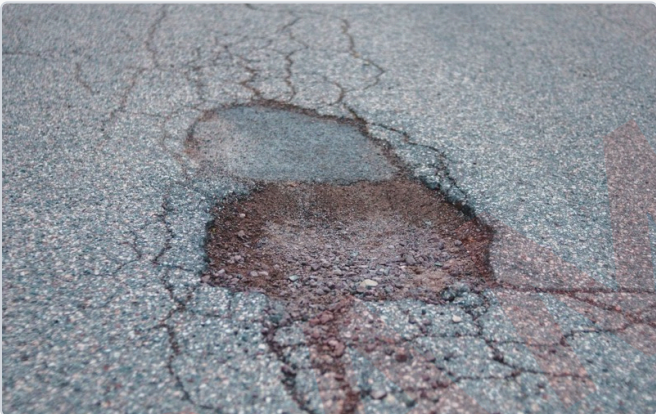
| Condition | The car park is tarmac over a hardcore base and serves eight bays. Two potholes have opened near the entrance, the larger roughly 400 mm across and 60 mm deep, and the surface around them is crazed and loose. Drainage falls are adequate and the gully is clear. Bay markings are faded but legible. |

2a Entrance: larger pothole with crazed, loose surface around it

| Action | Cut back the failed areas to sound material and patch with hot-laid tarmac, then seal the joints. Budget for an overlay of the whole surface within five years and repaint the bay markings at the same time. |

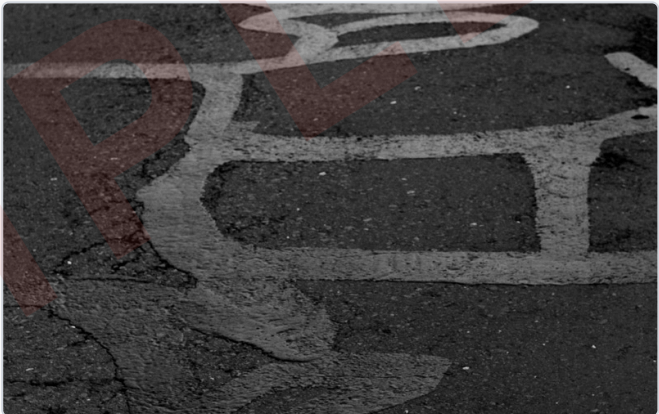
2b Bays: cracked and patched surface, markings faded but legible

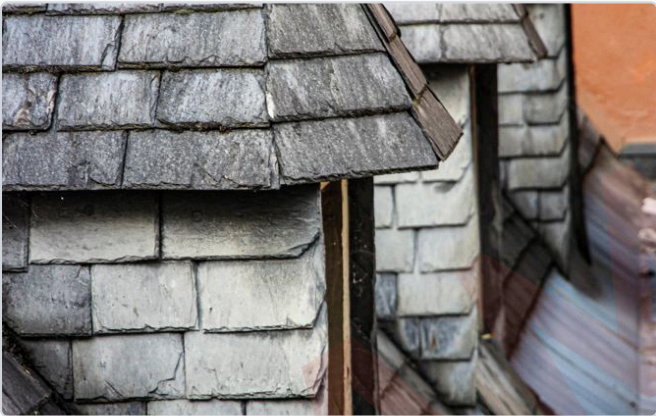
| Condition | Natural slate on sarking with a mortar-bedded ridge. Roughly a dozen slates on the front pitch have slipped or cracked and several have been patched in the past with lead tingles. The ridge mortar has weathered back and two ridge tiles have moved. The sarking boards visible from the loft are dry and sound. |

3a Front pitch: slipped slates and previous tingle repairs by the valley

| Action | Replace the slipped and cracked slates, re-bed the loose ridge tiles and repoint the ridge along the full length. Budget for re-slating within ten to fifteen years. |

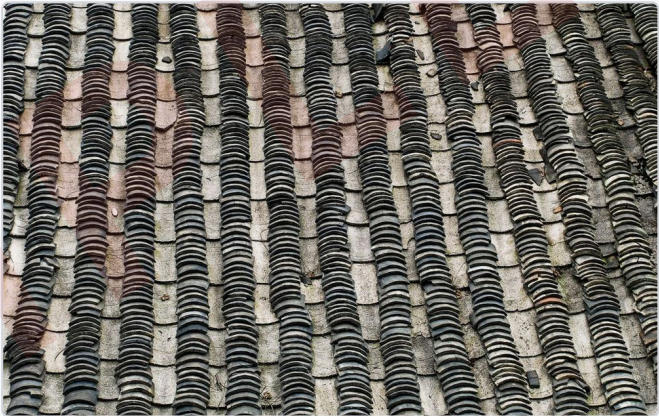
3b Ridge: weathered mortar and two moved tiles

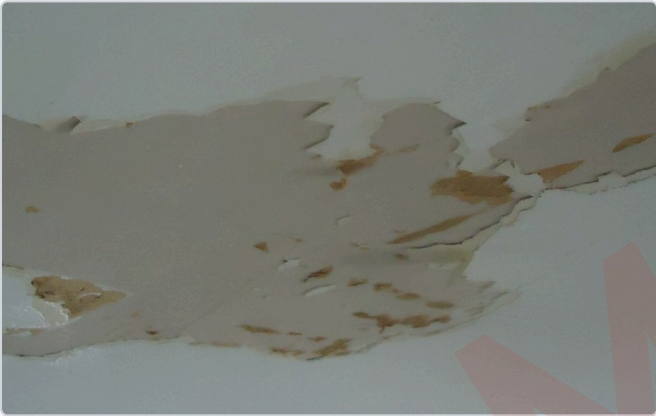
Condition Plasterboard ceiling with a skim finish. A tide-marked stain roughly 500 mm across sits below the valley gutter, with fine cracking through the skim. A moisture meter reading at the time of inspection was dry, which suggests a historic leak that has since been repaired at roof level rather than an active one.

4a Tide-marked stain below the valley gutter; dry at the time of inspection

Action No immediate action. Apply a stain-block primer and redecorate once a full winter has passed without the stain spreading. If it darkens or feels damp, have the valley gutter above re-inspected.

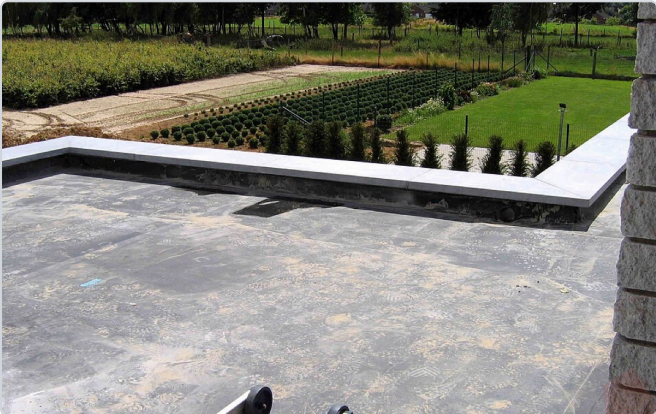
Condition EPDM rubber membrane renewed within the last few years. It is fully bonded with no splits or lifting at the edges, it is turned up under the stone coping, and the scupper outlet is clear. No ponding was noted and the ceiling below shows no staining.

5a Rear extension: EPDM membrane bonded and in good order

Action No work needed. Keep the outlet clear each autumn.

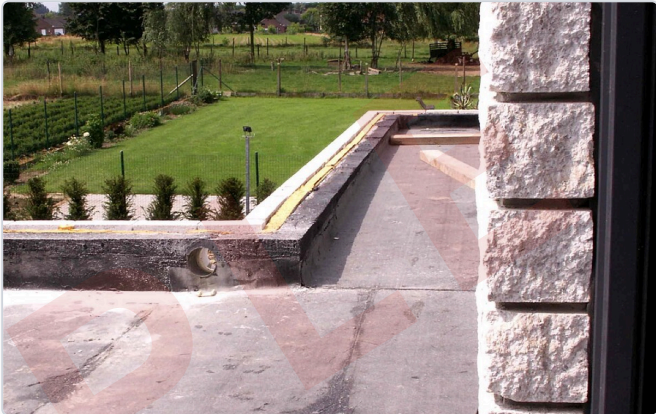
5b Scupper outlet through the upstand: clear
