## ROOF REPORT

**Mr and Mrs Fraser**

14 Elm Grove, Corstorphine, Edinburgh EH12 7AB

**Date of Survey: 08/09/2026**

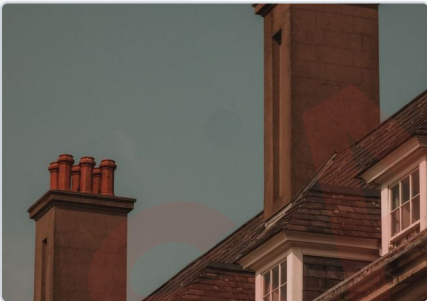
| Condition | There are three chimney stacks serving the property, two on the front elevation and one to the rear. The render on the front stacks has cracked and come away in places, leaving the brickwork exposed to the weather, and there is open jointing to the upper courses. The lead flashings at the base of the rear stack have lifted and no longer form a proper seal against the slates. Vegetation is growing from the mortar joints on the rear stack, which points to moisture sitting in the brickwork for some time. |

1a Front stacks: cracked render and open joints to the upper courses

| Action | Hack off the failed render on the front stacks and re-render with a keyed sand and cement mix with a bellcast at the base. Rake out and repoint the open joints on all three stacks, re-bed the pots and flaunching, and renew the lead flashings to the rear stack with Code 4 lead dressed into the slates. Remove the vegetation and treat the joints before repointing. |

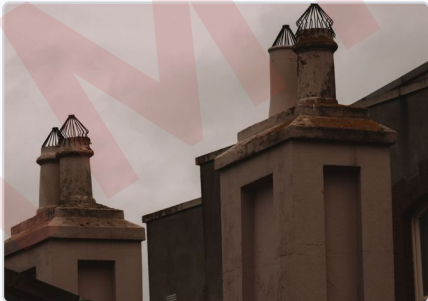
1b Rear stack: vegetation in the joints and lifted flashing at the base

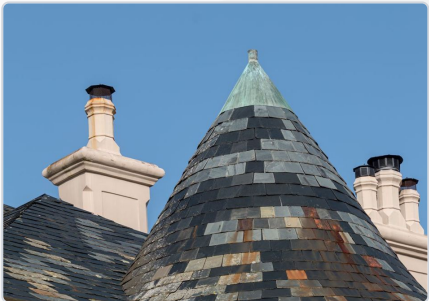
1c Rear stack from the ridge: flashing no longer sealed to the slates

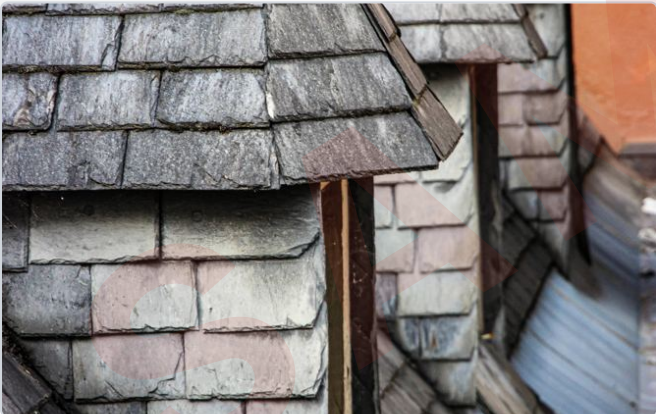
| Condition | The main roof is covered in natural slate on timber sarking and is original to the property. Roughly a dozen slates on the front pitch have slipped or cracked and several have been patched in the past with lead tingles. The ridge tiles are bedded in mortar that has weathered back and two have moved. Underneath, the sarking boards visible from the loft are dry and sound, with no sign of active water ingress at the time of the survey. |

2a Front pitch: slipped slates and previous tingle repairs by the valley

| Action | Replace the slipped and cracked slates with matching reclaimed slate on copper nails and remove the old tingles as each repair is made. Lift and re-bed the loose ridge tiles and repoint the remainder. The roof covering is serviceable with these repairs, but the client should budget for re-slating within ten to fifteen years given the age of the nails. |

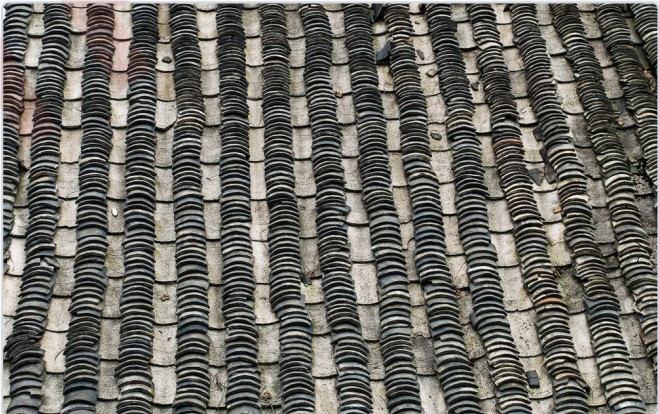
2b Slate covering generally sound; nail fatigue visible at the eaves

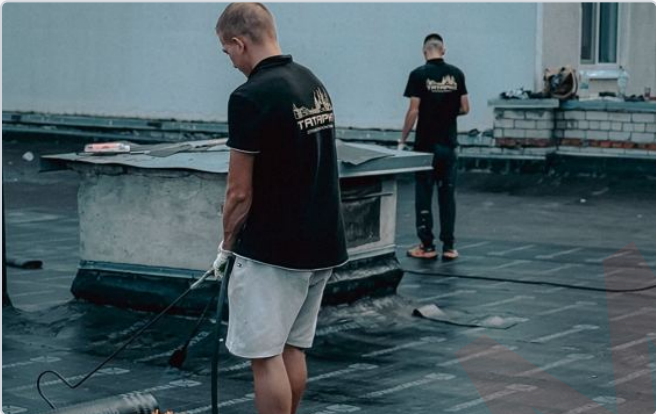
Condition      The single-storey rear extension has a torch-on felt covering that was renewed within the last few years. The laps are well bonded, the upstands to the main wall are dressed under a lead cover flashing, and the outlet is clear. No ponding was noted and the ceiling below shows no staining.

3a Rear extension: membrane in good order, outlet clear

Action      No work is needed at present. Keep the outlet clear of leaves each autumn and have the covering checked again at the next roof inspection.
